# Is It Efflorescence or Silicate Deposits?

By Ed McGettigan

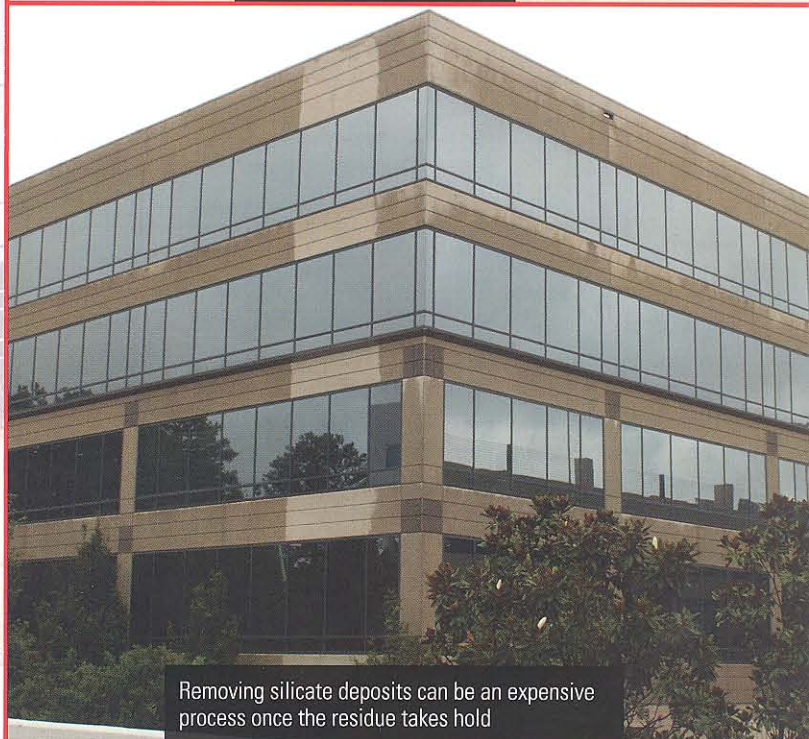
Removing silicate deposits can be an expensive process once the residue takes hold

Generally, the recommended procedure for removing silicate deposits is to polish the glass with an optical-grade cerium oxide. There are also proprietary cleaners available for removing stubborn stains. Whichever product is used, be careful to not scratch the glass. Also, don't polish the glass in direct sunlight, make sure the windows are clean to remove loose particles before polishing and remember there are about another 100 caveats.

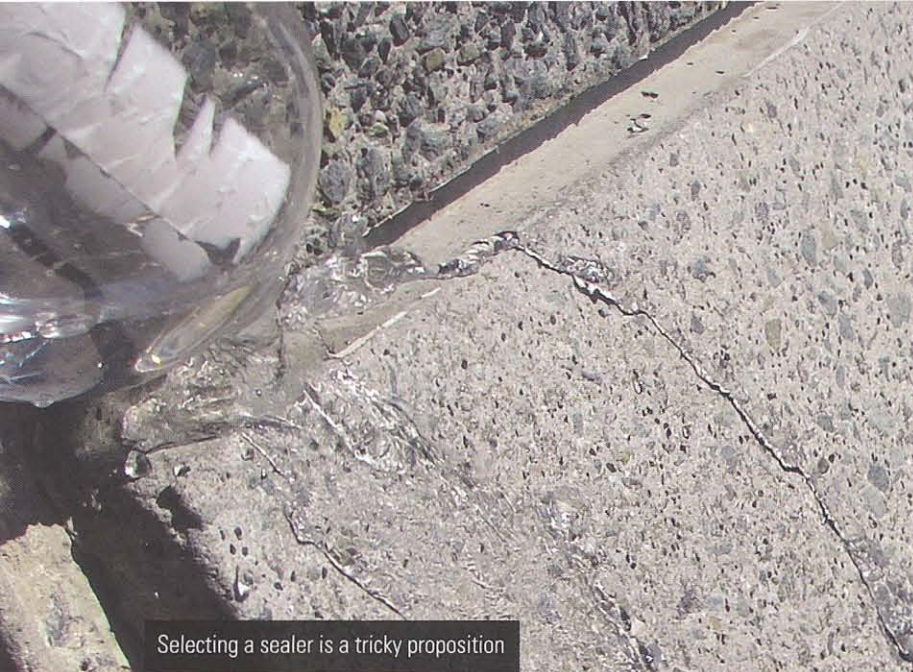
Selecting a sealer is a tricky proposition

Selecting a sealer based on its ability to bead water is an insufficient criterion when trying to stop silicate deposits. A more stringent test uses an alcohol- and water-based mixture. The alcohol lowers the water's surface tension, allowing it to spread and soak more easily over the treated substrate. Running this test after accelerated weathering provides a good indication of the long-term ability to keep silicate deposits from dissolving into rainwater.

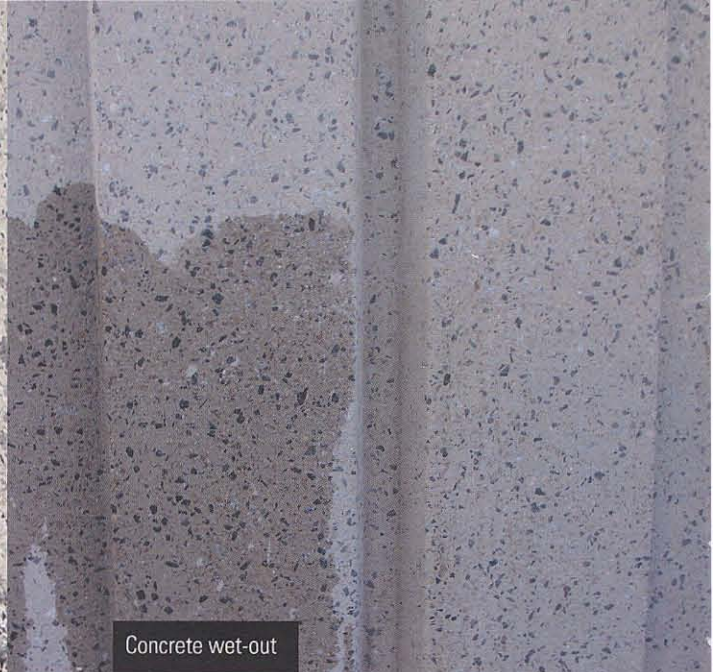
Concrete wet-out

Silane and siloxane – traditional water repellents – penetrate into the substrate to prevent traditional efflorescence, but have limited effectiveness against silicate deposits. Even so, they dramatically reduce water absorption into the concrete, preventing leaching of contaminants. The water repellent on the concrete's surface will breakdown via UV radiation within a few years, allowing the concrete to "wet out" during a rainstorm. Moisture then makes contact with and dissolves the silicates.

In order to mitigate silicate rundown, it is necessary to use a material that will keep the concrete from wetting out even during a wind-driven rain. Repelling a light or steady rain is easy for most clear sealers.

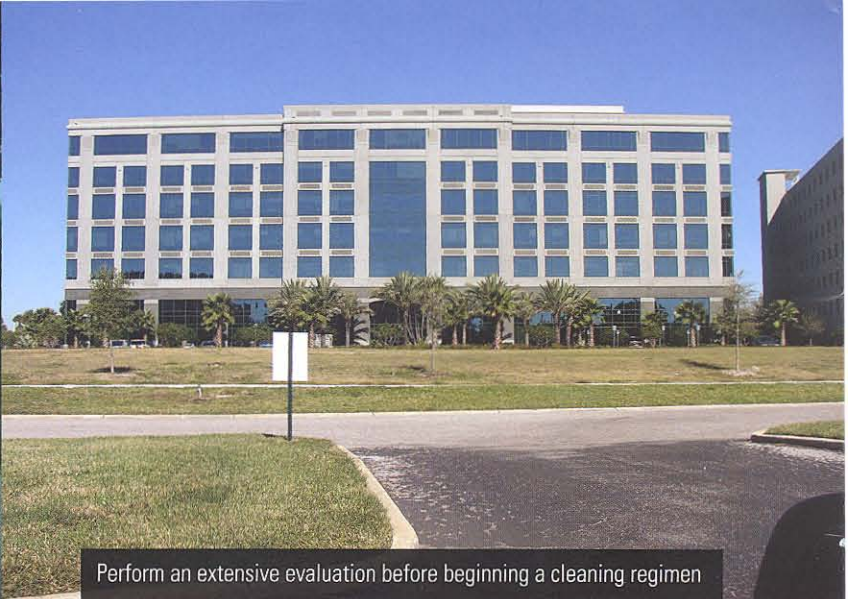
Perform an extensive evaluation before beginning a cleaning regimen

It is imperative to perform an extensive evaluation prior to beginning a cleaning regimen.
